## **ENERGY SAVINGS THROUGH PHOSPHATE-BONDED REFRACTORY MATERIALS**

Jens Decker  
Stellar Materials Incorporated  
7777 Glades Blvd, Suite 200, Boca Raton, FL, 33434, USA

## 10th Australasian Conference and Exhibition

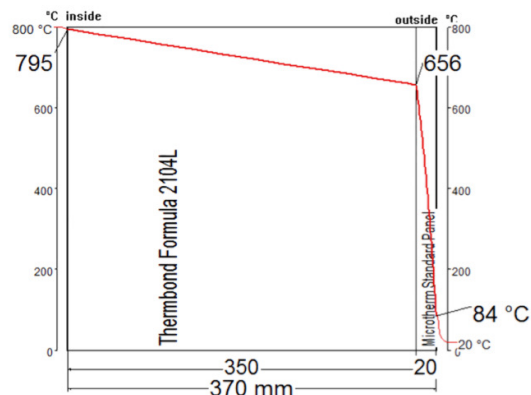
Figure 3. Thermal profile of a lining that uses a microporous insulation board.

Figure 3 shows a lining that uses a microporous insulation board with only 0.03W/m<sup>2</sup>°K thermal conductivity and a resulting 800 W/m<sup>2</sup> (254 BTU/sq.ft/h) heat loss. This would lead to more than 25% heat loss savings but the freeze plane of the aluminum can move into the microporous board leading to a higher risk of aluminum leakage.

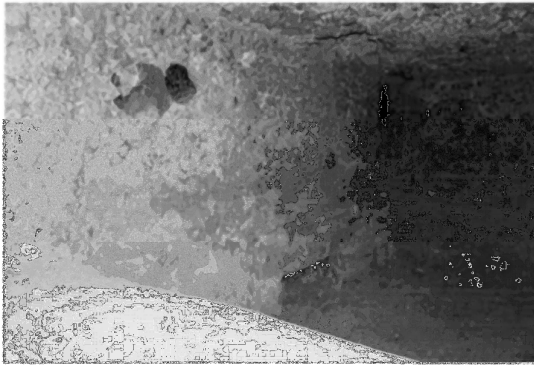
Figure 5. Same furnace wall shown in Figure 4 one year after reline with liquid phosphate-bonded refractory.

Due to the non wetting properties of liquid phosphate-bonded refractories, primary corundum build-up can be totally avoided. It also reduces the necessity and intensity of mechanical cleaning of the walls and the need for cleaning fluxes. The result is that phosphate-bonded materials do not show corundum build up and therefore eliminate related problems like production capacity losses and wall deterioration. Figure 5 shows the same furnace wall shown in Figure 4 after the reline with a liquid phosphate-bonded high alumina castable after one year. The wall stayed clean and the corundum build up problem was solved. Figure 6 shows a cup test conducted with an 85% alumina phosphate-bonded castable tested with 7075 alloy enriched with 5% Mg. The test temperature was 1800°F and the holding time 120 hours. The result shows that phosphate-bonded materials are resistant to high Mg-alloys which potentially cause spinel formation and consequently cracking of the refractory lining.

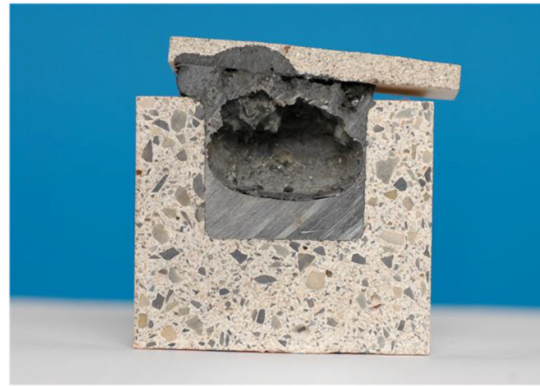
Figure 6. Castable refractory cup test shows phosphate-bonded materials are resistant to high Mg-alloys.
