APPLICATION REPORT

Floor Repair, Steel Plant- Casting, Screeting and Finishing

Description of Equipment: High traffic floor in front of electric arc furnaces

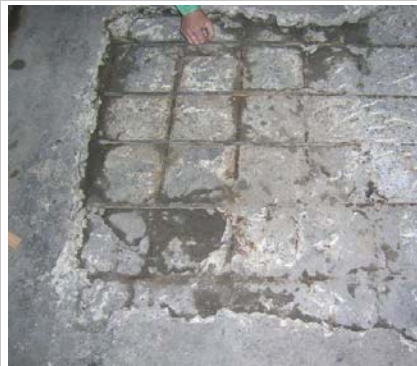
Problem: Existing concrete was severely damaged due to forklift traffic and heavy loads placed on floor. Large holes in the floor caused major safety concerns for both forklift and foot traffic. High temperature mortar used to repair surface lasted only three weeks. Customer was looking for a longer lasting solution. Repairs had to be made with limited interference of operations.

Damaged floor with rebar exposed.

Solution: Phoscrete 602-L was recommended because of its rapid setting, high strengths, and most importantly, Phoscrete's ability to bond to existing concrete.

Scope of Work: Removed loose concrete and blew out dust. Poured Phoscrete 602-L across the area, vibrated the material into place and finished surface using cement hand floats.

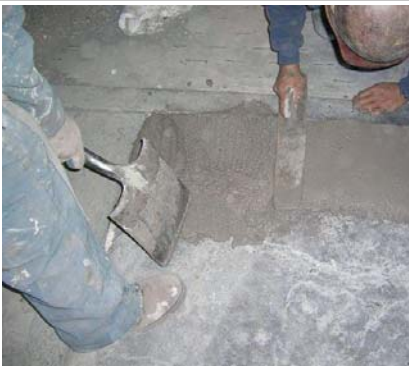
Placing of Phoscrete 602-L

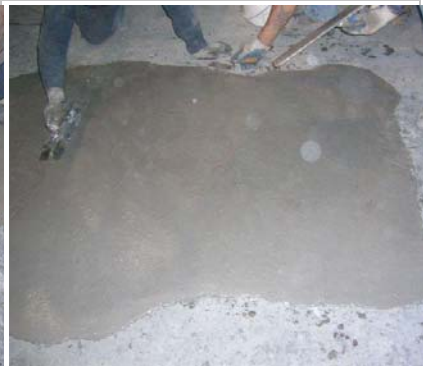
Finishing surface.
